Troubleshooting Guide E21 TUBE INTERLOCK ERROR

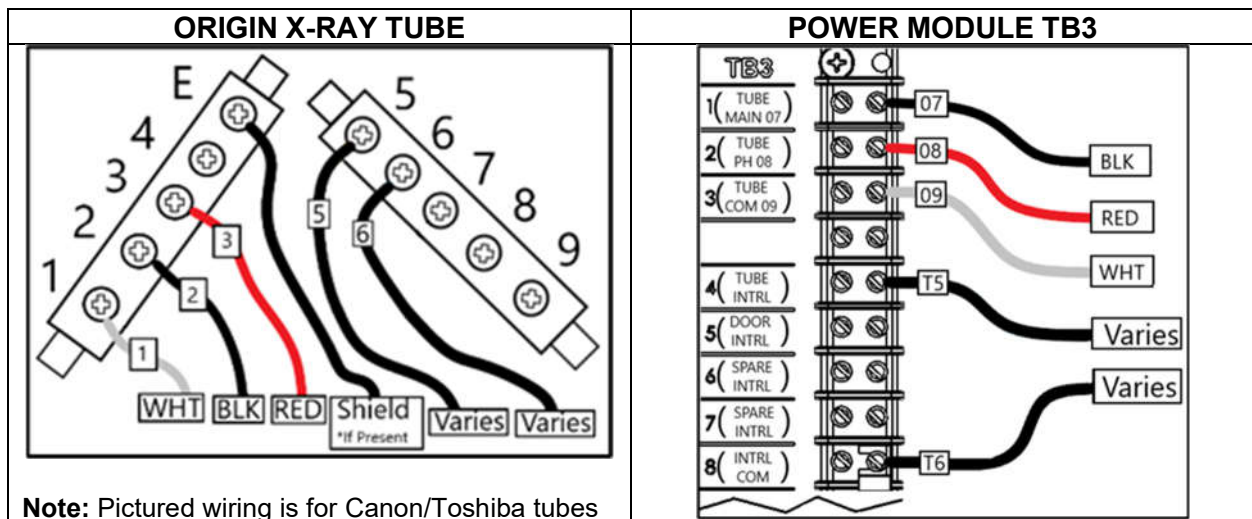
- a) X-ray tube thermal switch connections @ TB3-4 & TB3-8 or TB3-9 (INTRL COM).
You can add a jumper between TB3-4 & TB3-8, and verify:
 - If the error persists, keep the jumper attached and go to step d).
 - If the error disappears, remove the jumper and go through steps b) and c).
- b) Thermal switch @ the X-ray tube: using an OHM meter to verify resistance of thermal switch to be less than 1 (one) Ohm. If OPEN, replace thermal switch or X-ray tube.
- c) Stator cable (bring spare) in case of break in cable...
- d) Using an OHM meter to verify resistance from header H10 pin 7 to pin 1 (System Controller Board) to be less than 1 (one) Ohm.
 - If not, verify & repair (if needed) harness connections from header H10 pin 7 to TB3-4, and header H10 pin 1 to TB3-8.
 - If resistance measured is less than 1 (one) Ohm, replace System Controller Board w/Kit 06357-XXX. **Contact Tech Support**
