Technical Publication
TR-1005R8

Troubleshooting

HF Series Generators
with Low or High Speed Starter

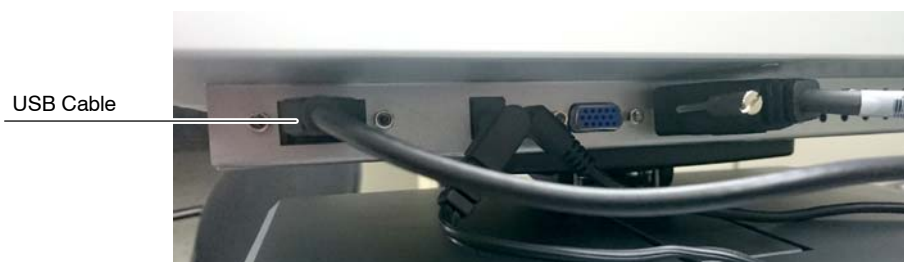
1. With the CTSC Console OFF disconnect the USB Cable of the Monitor.

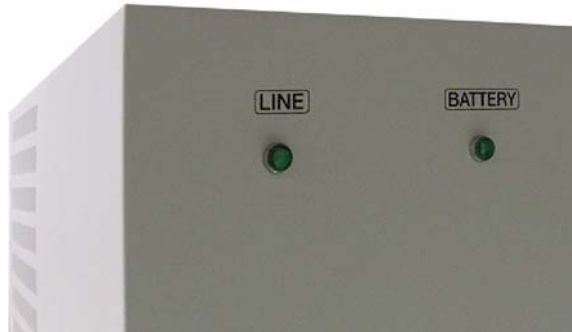
Check that the external “Power Line Indicator Lamp” (LINE) lights when the Generator is connected to the mains, that is in charging mode of the batteries.

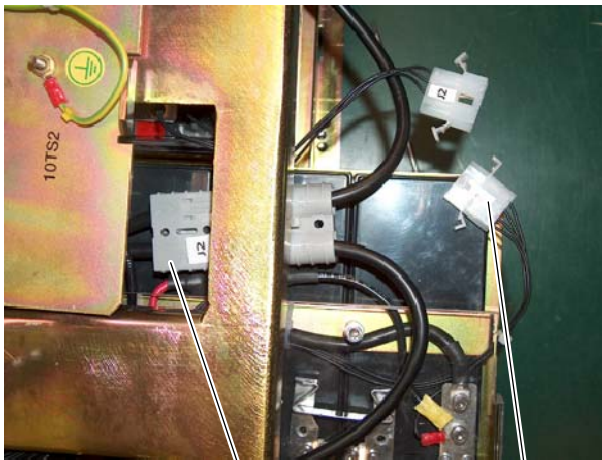
Anderson Connectors

Molex Connector

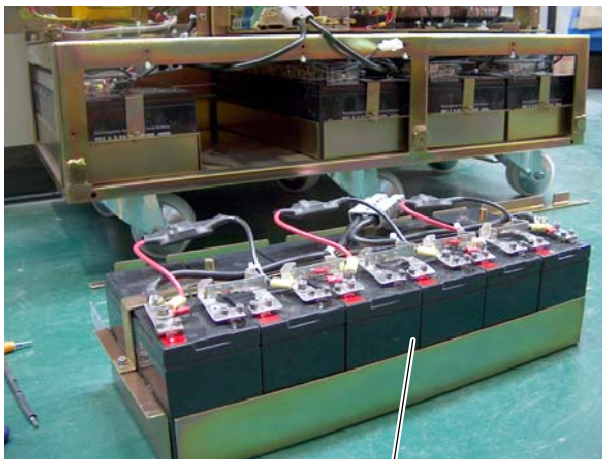
Battery Tray

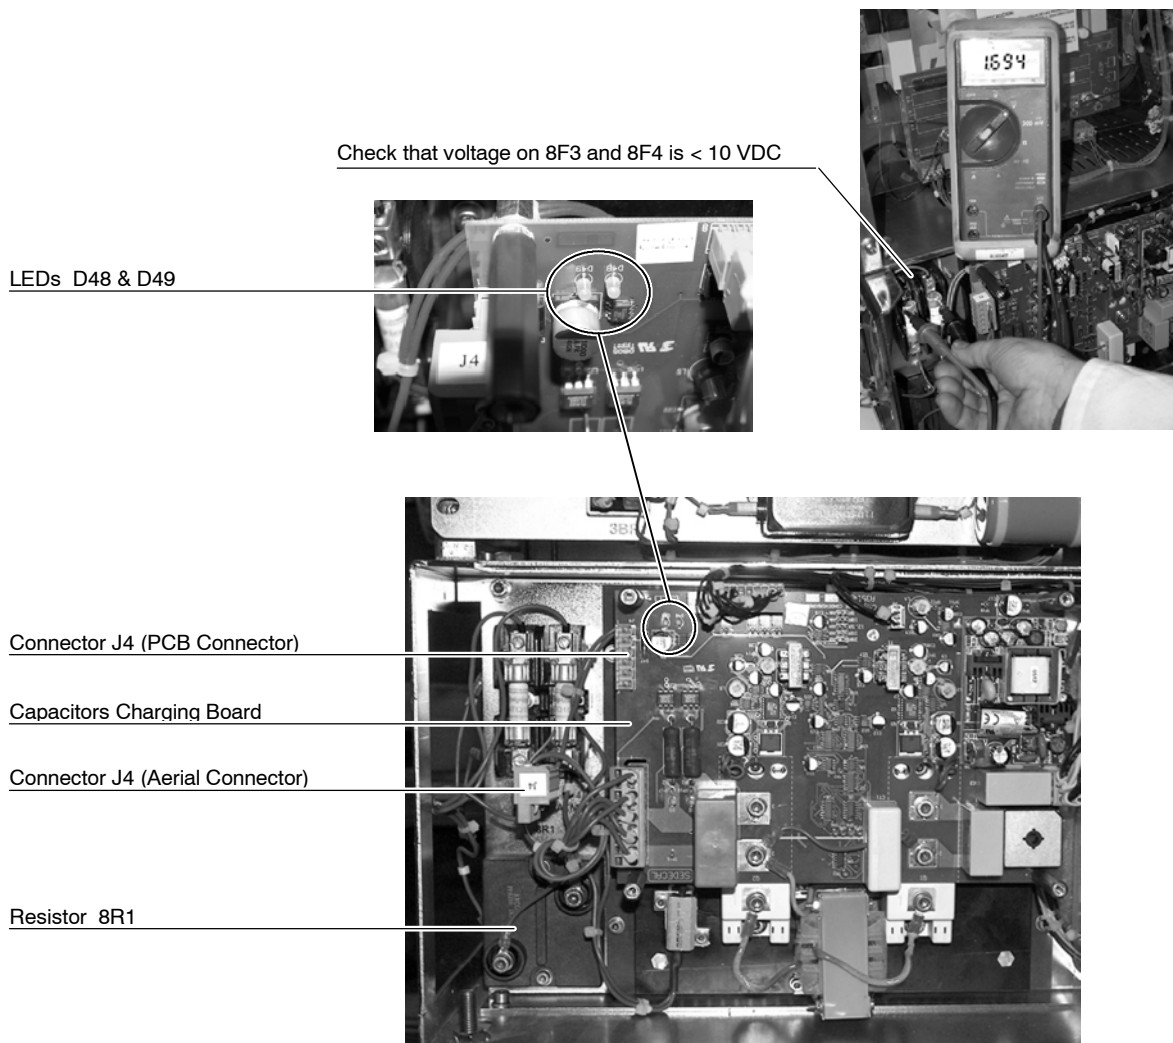
Illustration 2-5
Connection of J4 for Capacitor Discharging

6. Check that the voltage stored in Capacitors is < 10 VDC (maximum voltage for a safe service manipulation). It is recommended that voltage will be close to 0 VDC. For that, check that LEDs D48 and D49 are OFF, and then measure the voltage at the base of Fuses 8F3 and 8F4.

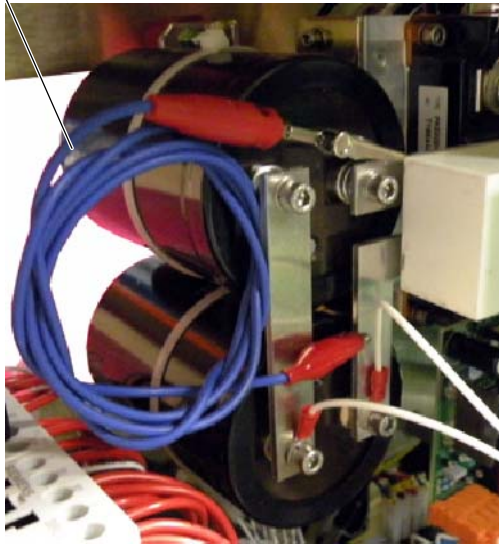
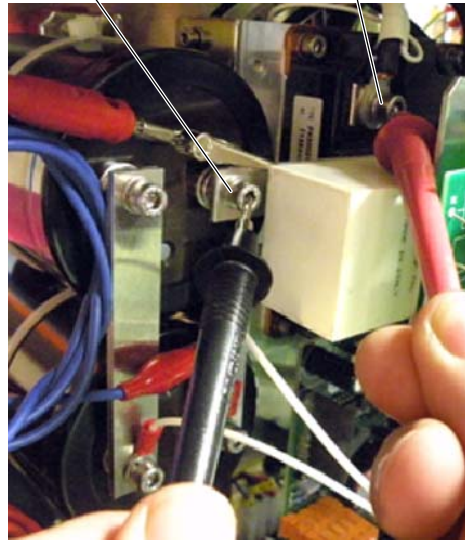
Illustration 4-2
Jumper and Measurement Points

Jumper between DC-BUS+ and DC-BUS-

E2 C2E1

3-PHASE LINE POWERED GENERATOR OR CAPACITOR ASSISTED GENERATOR

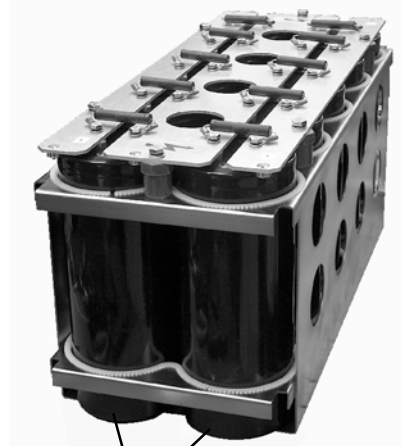
- If balance is not correct and the voltage difference is the same measured in step 1. Turn the Generator OFF and discharge the Capacitors as described in Section “*Procedure for Storage Capacitors Discharging and Voltage Testing*” of this chapter. Connect the first pair of Capacitors again. Disconnect and isolate the second pair of Capacitors. Turn the Generator ON and check if the voltage in the Capacitor Bank is balanced or not. Follow this procedure with the rest of Capacitor pairs.

- If after checking a pair of Capacitors, the balance is correct or the voltage difference is reduced in approx. 50 V, replace this pair of Capacitors and follow checking the rest of Capacitor pairs as indicated before.

First pair of Capacitors
