# Troubleshooting Guide

## E26 STILL ANODE ERROR

**No ROTOR Current Sense during PREP.**

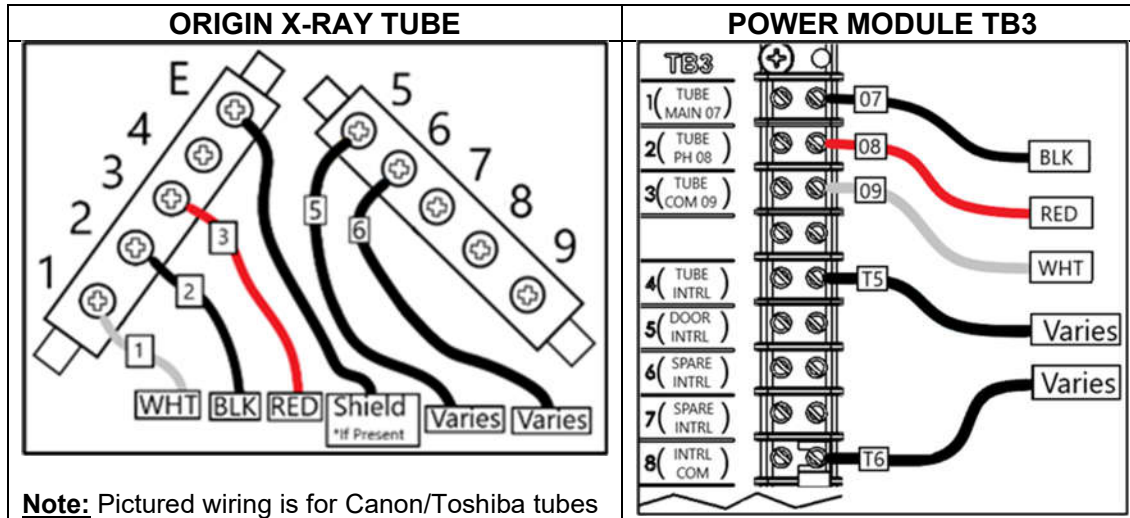
1. Confirm X-Ray Tube stator connections and stator resistance.

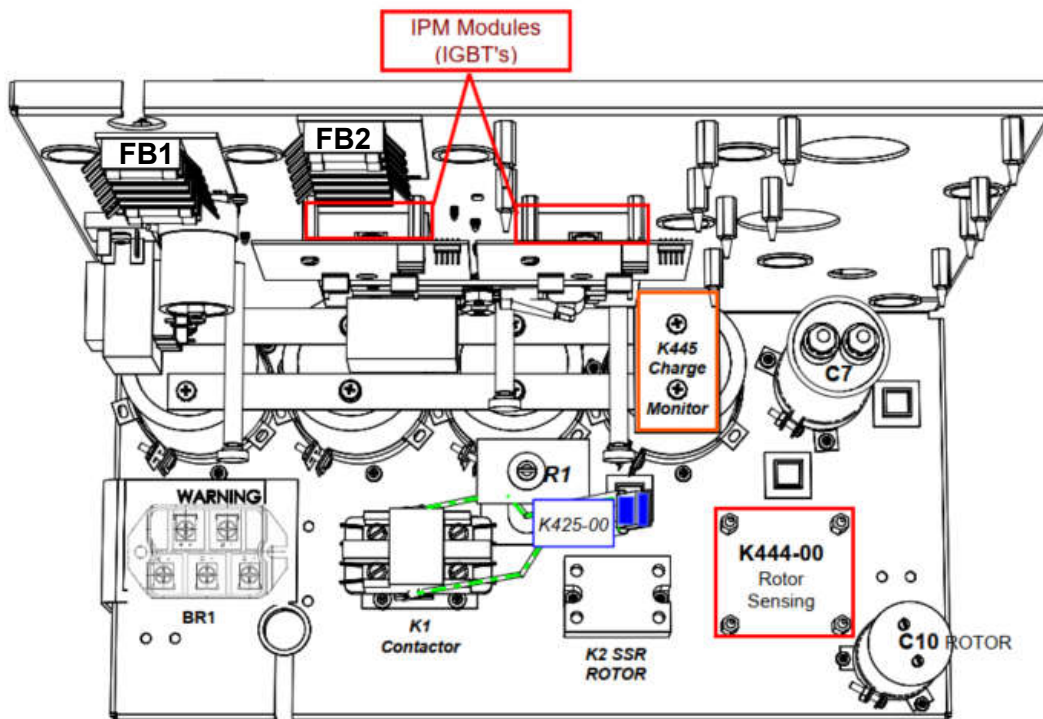
TOP VIEW CHASSIS

2. Check chassis fuses F13 & F14 @ FB2 (Fuse Bank 2)
3. Confirm if AUX CAPACITOR (PHASE SHIFT CAP) is disconnected or needing replacement. Chassis C10 capacitor is located on the FRONT RIGHT corner.
4. Check ROTOR SENSE BOARD (K444-00) for failure. (Left of the C10 capacitor)
5. Check if K2 (SSR) rotor module is triggering and delivering power during PREP.
6. Check SYSTEM CONTROLLER BOARD for H8 & H9 header connections not crossed.
