# Know the Signs

## QUICK TECH TIP

### A quick visual check that can prevent bigger problems

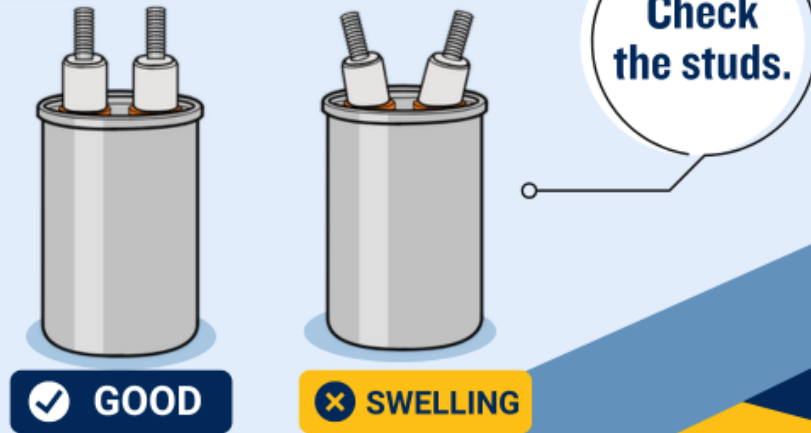
The C7 capacitor resembles a small soda can with **two threaded studs on top**. Under normal conditions, these studs should be **straight and parallel**.

If you notice the studs beginning to **lean away from each other**, the capacitor may be bulging/swelling. This is a common sign that the component is failing and may no longer be operating properly.

- PN for 240VAC: L297-00
- PN for 480VAC: HAT26

*When in doubt, change it out!*
